SB621531

# Service Information

### Coolant Level in Expansion Tank

E53 X5, E38 740, E39 540 All with M62 and M62TU engine

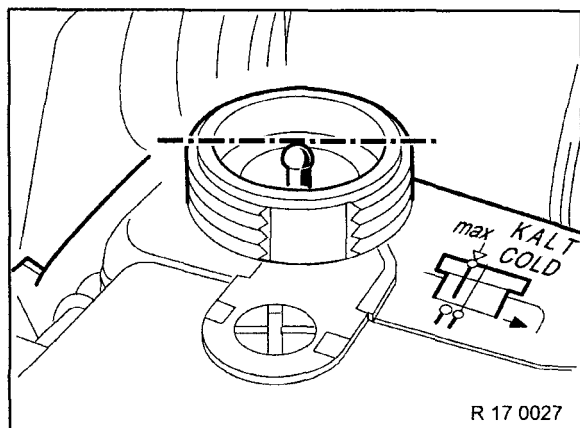
Black expansion tanks with float rod (E38 shown):

**The coolant level must be checked with the engine cold.**

Note: The coolant temperature must not exceed 30°C (86°F). If the ambient temperature is greater than 30°C (86°F), allow the engine to cool down to the ambient temperature.

Top up coolant until the upper end of the red float rod is even with the upper edge of the expansion tank filler neck as shown in the illustration.

Note: Since the level rod and coolant tank will vary depending on model, follow the cold level instructions located on top of the expansion tank when checking level.

Do not over fill.
